Study of the wear process and damage characteristics of the “stationary shaft–bushing” tribological pair

The article investigates the causes of surface degradation in the “stationary shaft–bushing” tribological pair of the roller assembly of a diesel engine fuel pump plunger in a heavy-duty truck, operating under increased loads and boundary lubrication conditions. A surface damage passporting methodology was applied, including analysis of microhardness, surface roughness, geometrical accuracy, and structural transformations within surface layers of the components, supplemented by elements of X-ray diffraction analysis.

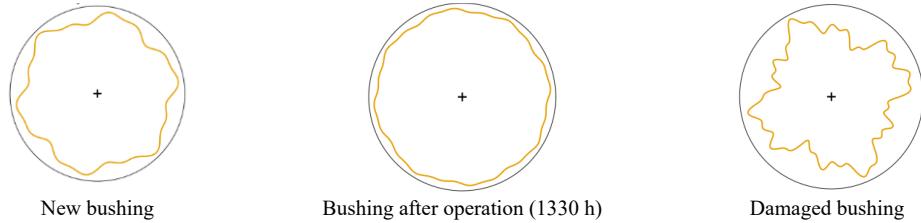
Bushings that have operated for 1330 hours under normal service conditions demonstrated the smallest non-uniformity of profile deviation — the polygonalization in this case is practically reduced to minor ovality

Thus, the analysis of internal bushing geometry based on roundness profiles confirms that increased mechanical loading and unstable lubrication result in accelerated wear of the working surfaces, which consequently causes failure of the friction unit.

Fig. 1. Roundness profiles of the internal surface of bushings in the “shaft–bushing” friction pair after different operating conditions

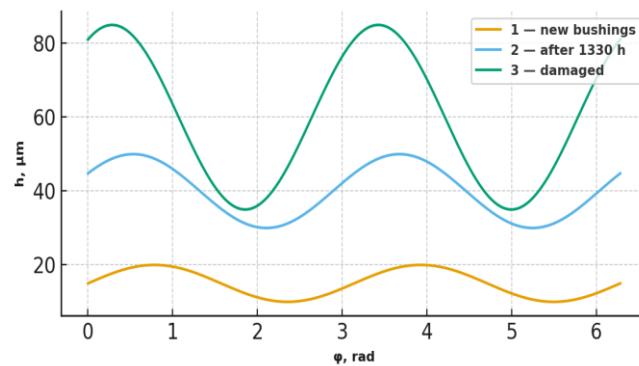
(Fig. 2, curve 1). New bushings are characterized by a tetragonal profile shape (Fig. 2, curve 2), indicating manufacturing inaccuracies and insufficient quality of finishing operations. The most pronounced multi-polygonal deformation was observed in bushings damaged during bench operation under increased axial loads (Fig. 2, curve 3), which leads to localized increases in contact stresses and promotes the development of hot scuffing.

Fig. 2. Form deviation of the internal bushing surface after different operating conditions: 1 - new bushings; 2 - bushings after 1330 h of operation; 3 - bushings damaged during bench testing under increased loads

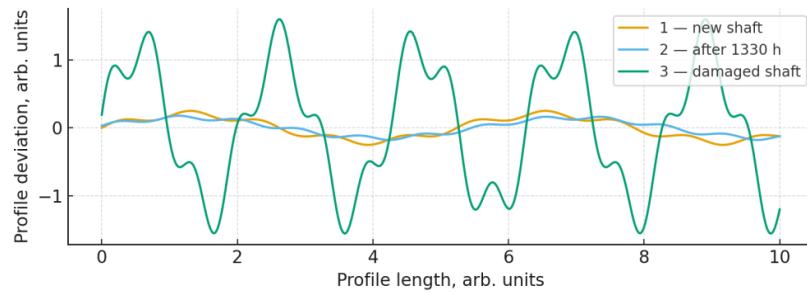
The surface topography analysis of the shafts in the new condition, after 1330 hours of operation, and after damage under increased loading conditions (Fig. 3) showed that normal operation results in a significant reduction of surface roughness compared to the new component due to running-in processes and plastic smoothing of asperities under mixed friction conditions. The machining quality of the new shaft’s outer surface ($R_a \approx 1.6 \mu\text{m}$) is significantly higher compared to the bushing’s internal surface ($R_a \approx 58 \mu\text{m}$), which does not meet the requirements of technical specifications stating that the roughness parameters of contacting elements must be compatible. Such inconsistency deteriorates the formation of a stable lubricant film and promotes localized concentration of contact stresses. The microhardness characteristics of the shaft surface layer are shown in Fig. 4. The average surface microhardness of the new shaft is approximately 5500 MPa (Fig. 4, curve 1), and the microstructure consists of hardened martensite with a high level of residual stresses. This provides increased initial wear resistance; however, it also creates susceptibility to thermal cracking and the formation of “white layers” in cases of overheating under boundary lubrication conditions.

Fig. 3. Profilograms of the working surface of shafts in the “shaft–bushing” friction pair: 1 - new shaft (vertical scale $\times 10\,000$; horizontal scale $\times 80$); 2 - shaft after 1330 h of operation (vertical scale $\times 10\,000$; horizontal scale $\times 80$); 3 - shaft damaged during bench testing under increased loads (vertical scale $\times 4000$; horizontal scale $\times 80$).

After 1330 hours of operation, strengthening of the shaft surface layer was observed, associated with work hardening and phase transformations under variable loading. In contrast, the damaged components show the formation of a secondary-hardened “white layer” with an abrupt increase in hardness, which indicates thermal overload and serves as an initiator of hot scuffing.

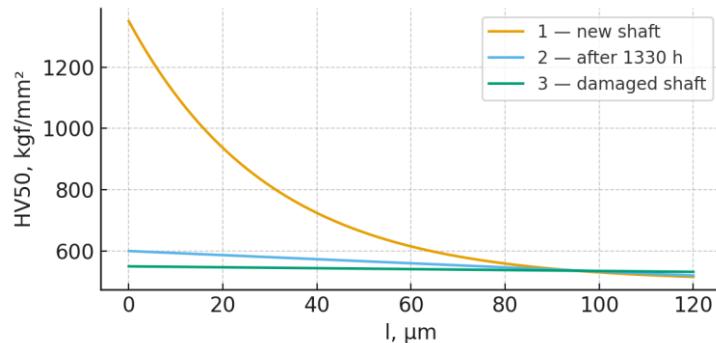
During normal operation of the assembly, strengthening of the surface layers occurs due to work hardening and stabilization of secondary structures. It was established that after 1330 hours of operation, the surface microhardness of the shaft increases to approximately 6060 MPa (Fig. 4, curve 2), indicating partial transformation of the material into martensite, which is more resistant to wear. In this case, a reduction in micro-relief depth was observed already at the running-in stage.

In contrast, on the surfaces of damaged bushings and shafts that operated under increased mechanical and thermal loads, localized formation of a densified “white layer” with significantly higher hardness was detected (Fig. 4, curve 3). The microhardness of this layer exceeds the initial value nearly twofold, indicating the development of secondary hardening and the formation of a brittle structure with a high tendency to delamination. The presence of a white layer implies that temperatures in specific contact points reached levels sufficient to initiate thermal plasticity of the surface layers, reducing their strengthening and followed by rapid cooling when metallic junctions are ruptured. Such thermodynamic instability is the major driving factor behind the development of hot scuffing.

The results of X-ray diffraction analysis confirm the formation of new Fe_{γ} -type phases characteristic of rapid surface cooling after localized overheating, which is consistent with the mechanism of secondary hardening under boundary friction conditions.

Fig. 4. Distribution of HV50 microhardness within the surface layer of the shafts in the “shaft–bushing” friction pair after different operating conditions: 1 - damaged shaft (secondary hardening, “white layer”); 2 - shaft after 1330 h of normal operation; 3 - new shaft.
