## Analysis of damage to ceramic balls in hybrid rolling friction pairs

<sup>1</sup>Kyiv Aviation Institute, Kyiv, Ukraine

<sup>2</sup>V.M. Bakul Institute of Superhard Materials, National Academy of Sciences of Ukraine

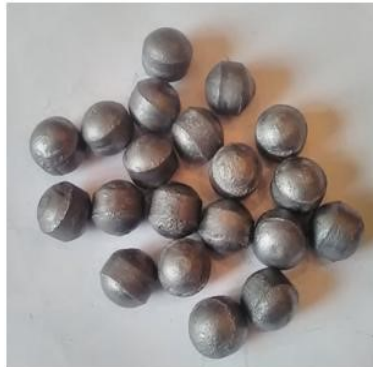
**Fig. 2. General view of sintered ceramic ball blanks**

The materials and dimensions of the components of the reaction cell were preliminarily calculated in order to obtain a temperature distribution during billet sintering with a minimum temperature gradient along the diameter [9]. The layout of the reaction vessel for sintering ceramic ball blanks under high pressure is shown in Fig. 1, a. Cold pressing of ceramic ball briquettes was performed in steel moulds under a pressure of 180-200 MPa. After cold briquette pressing, the billets had a diameter of 15.4 mm and a total height of 19 mm. The compressed briquettes were placed in a container of a high-pressure apparatus. The sintering temperature of the billets was 1650°C, the pressure was 4 GPa, and the duration was  $\tau = 4$  min. After sintering, the diameter of the billets was reduced to 13.5 mm and their height to 13.44 mm (Fig. 2).

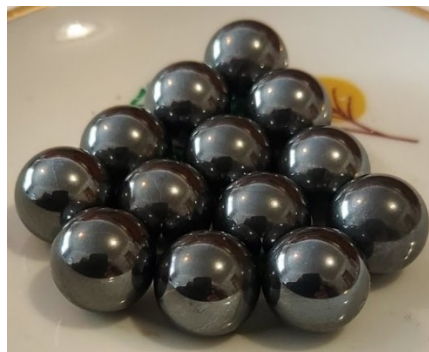
Fig. 3. General view of ceramic balls with a diameter of 12.7 mm after diamond processing

Samples of precision ceramic balls were made from sintered  $\text{Si}_3\text{N}_4$  billets (ESWT). At the preliminary stage, the workpieces were ground according to the scheme between two discs, one of which (upper) is a diamond wheel, and on the plane of the second (lower), located eccentrically, freely rotating balls had a circular feed. At the next stage, the precision balls were ground between two discs in a V-shaped annular groove in several stages with a consistent decrease in the diamond slurry grain size from ASM 28/20 to ASM 1/0 [17]. Thus, the test samples of balls with a diameter of 12.7 mm had a deviation from the spherical shape of 0.4  $\mu\text{m}$  and a surface roughness of  $R_a$  0.025 (accuracy class G16 according to ISO 3290-2:2014) [17,18] - Fig. 3.

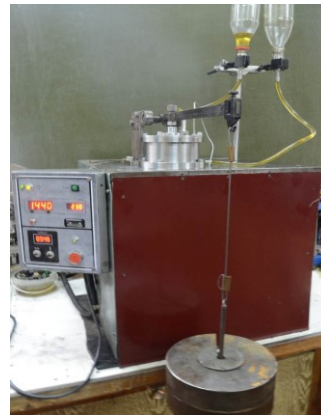
**Fig. 4. Scheme of testing a hybrid rolling friction pair [19] - (a); General view of the setup for tribological testing of ceramic balls - (b)**

In order to determine the wear resistance of balls in the  $\text{Si}_3\text{N}_4$  ceramic - SHKH-15 steel system under lubrication with an oil-vapour-gas mixture (TC-1 and MC-8p oil), a rapid test method was developed taking into account the geometric and kinematic parameters of the test assembly on the laboratory device for unidirectional three-point rolling friction KIIGA-1m (Fig. 4) [19,24].

The test assembly of the device simulates the geometry of the contact of rolling friction of balls on a steel support (Fig. 4), which allows simulating the friction processes of a real tribosystem of a deep groove ball bearing. The balls were centred using the standard raceway of the steel bearing ring, and the upper ring was mounted with a flat working surface.

A stationary thrust ball bearing ring 8211 made of steel SHKH -15 was mounted on the holder, with the standard raceway facing outwards. At the bottom of the chamber, namely on its lower surface, a movable sample (lower thrust ball bearing ring, steel SHKH -15) was mounted up the previously finished working surface, on which a separator with test ball samples was installed. After that, the separator was centred relative to the centre of rotation by positioning the balls in accordance with the raceway of the standard ball bearing ring pre-installed on the holder's seating surface. The chamber was filled with lubricant, and the necessary calibrated weights were placed on the lever of the loading system. The total time for the tribological tests was up to 6 hours. The wear rate of the lower steel ring was based on the linear wear of the ball bearing working surface and the weight loss of the test balls measured by profiling.
